Contract #: 04-0120F4Cty: SF/ALA Rte: 80 PM: 13.2/13.9File #: 1.28**WELDING INSPECTION REPORT****Resident Engineer:** Casey, William**Address:** 333 Burma Road**City:** Oakland, CA 94607**Report No:** WIR-028235**Date Inspected:** 21-Aug-2012**Project Name:** SAS Superstructure**OSM Arrival Time:** 700**Prime Contractor:** American Bridge/Fluor Enterprises, a JV**OSM Departure Time:** 1930**Contractor:** American Bridge/Fluor Enterprises, a JV**Location:** Job site**CWI Name:** Salvador Merino**CWI Present:** Yes No**Inspected CWI report:** Yes No N/A**Rod Oven in Use:** Yes No N/A**Electrode to specification:** Yes No N/A**Weld Procedures Followed:** Yes No N/A**Qualified Welders:** Yes No N/A**Verified Joint Fit-up:** Yes No N/A**Approved Drawings:** Yes No N/A**Approved WPS:** Yes No N/A**Delayed / Cancelled:** Yes No N/A**Bridge No:** 34-0006**Component:** OBG**Summary of Items Observed:**

Magnetic Particle Testing (OBG 13E)

Ultrasonic Testing (OBG 13E)

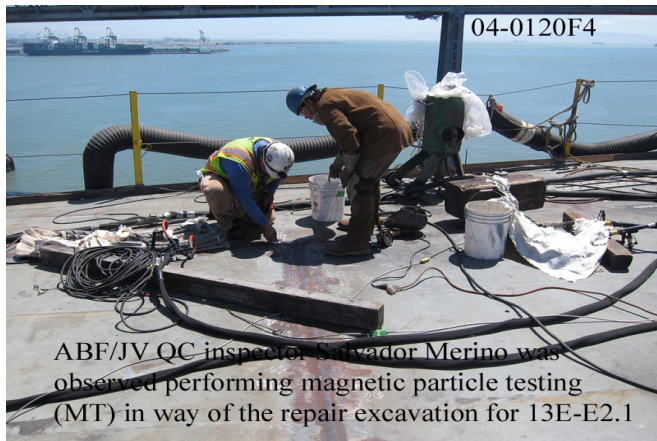
The welds were initially rejected visually due to excessive reinforcement. Minor repair by grinding was performed prior to acceptance. No indications were observed at the time of inspection.

The weld was rejected visually due to excessive reinforcement and underfill between panel point 123 and 123.5. No indications were observed outside of the noted area. The weld will require further re-work on face B between panel point 123 and 123.5 at a later date.

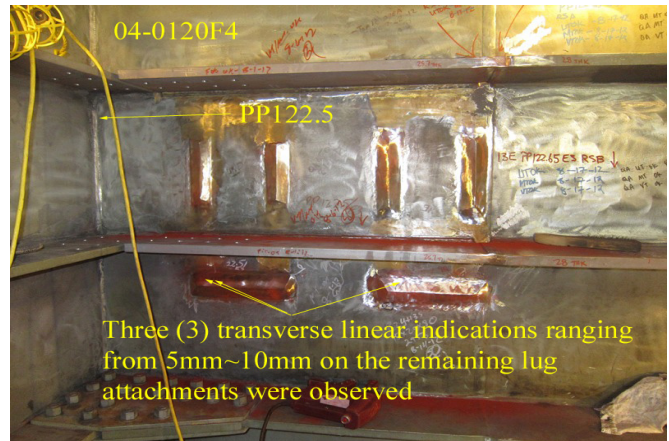
The QAI observed ABF/JV qualified welder Wai Kitlai #2953 performing Carbon Arc Gouging (CAG) for the repair of the deck panel drop-in splices designated as 13E-E2.1 and 13E-PP120.6. The ABF/JV QC inspector Salvador Merino was observed performing magnetic particle testing (MT) in way of the repair excavations at the

Y=2560 Depth 10, Width 16mm, Length 80mm

The ABF welder Wai Kitlai was observed later in the shift performing Shielded Metal Arc Welding (SMAW) in the 4G position utilizing the Caltrans approved Welding Procedure Specifications ABF-WPS-D1.5-1004-Repair at the locations previously noted. The weld and surrounding area was brought to a temperature of 325°F by the use of inductions heaters and maintained throughout the welding process. Due to the first time repair at these locations approval of the engineer is not required.

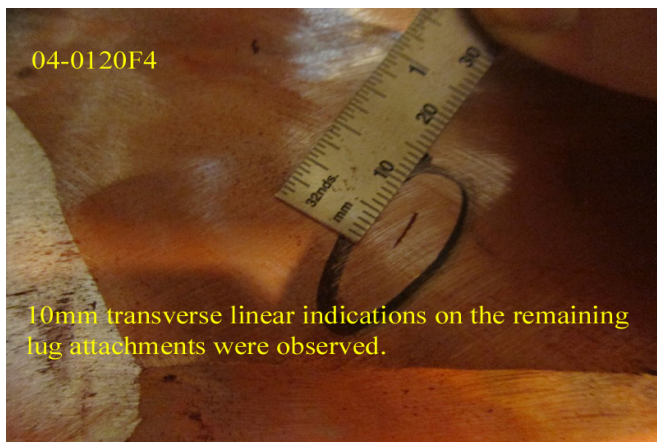
The QAI performed a minimum of 30% random verification of this weld. A total of three (3) rejectable indications were observed by the QAI at the time of inspection. All indications found were confirmed by ABF QC inspector Jesse Cayabyab during this shift.
